Phase I Environmental Site
Assessment

Chinook Ridge - Proposed Golf
Course

Portion of SE-31-028-03-W5M
Cochrane, AB

PROJECT NO. 149104750.500

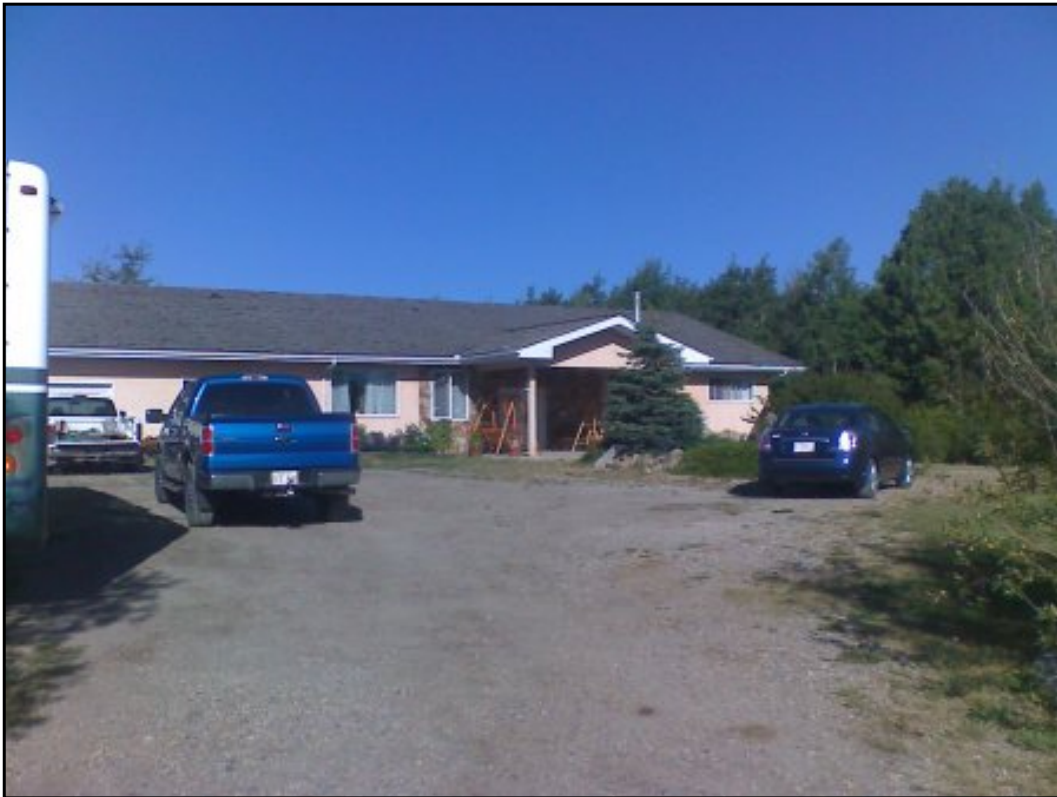
The site building is primarily a wood-framed structure. The roof consists of cedar shake, and the exterior walls are stucco. The site building is constructed on a concrete foundation. Interior finishes consist of gypsum board. The storage shed is constructed entirely out of wood and sits on wooden skids. The Hay Shed is built on a concrete floor slab and constructed with double hoop engineered 16 gauge steel overlaid with vinyl covering.

Residential property located on the Site.

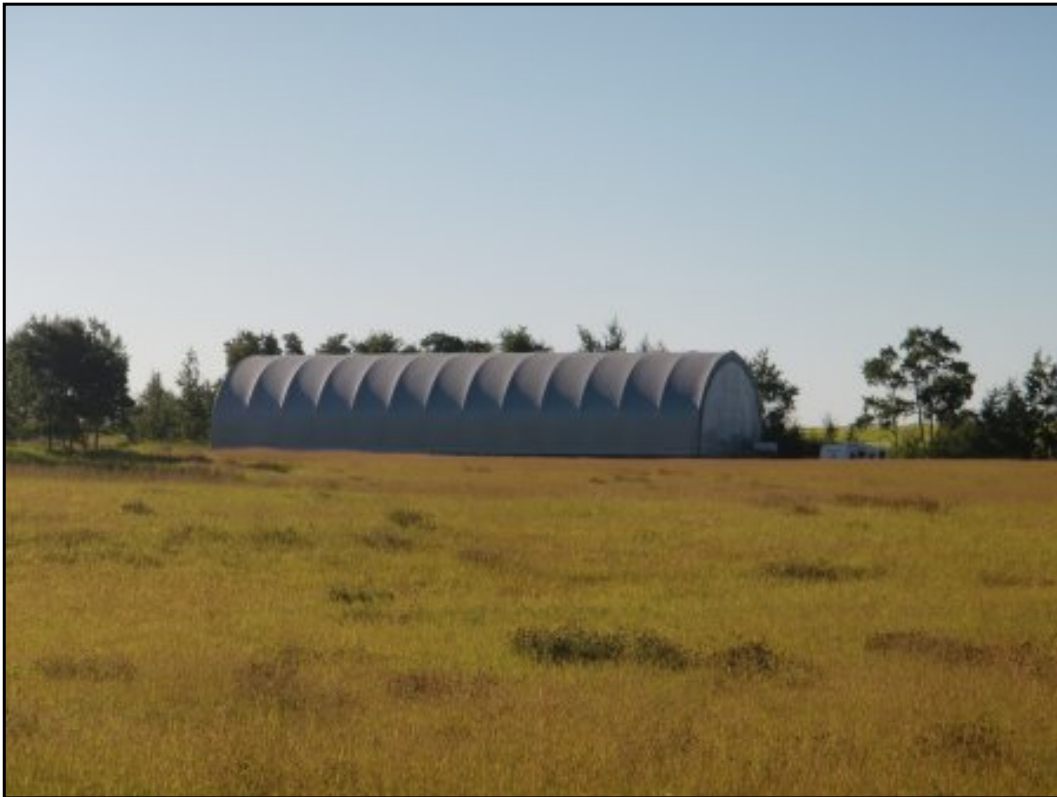
Hay shed located in the southeast portion of the Site.

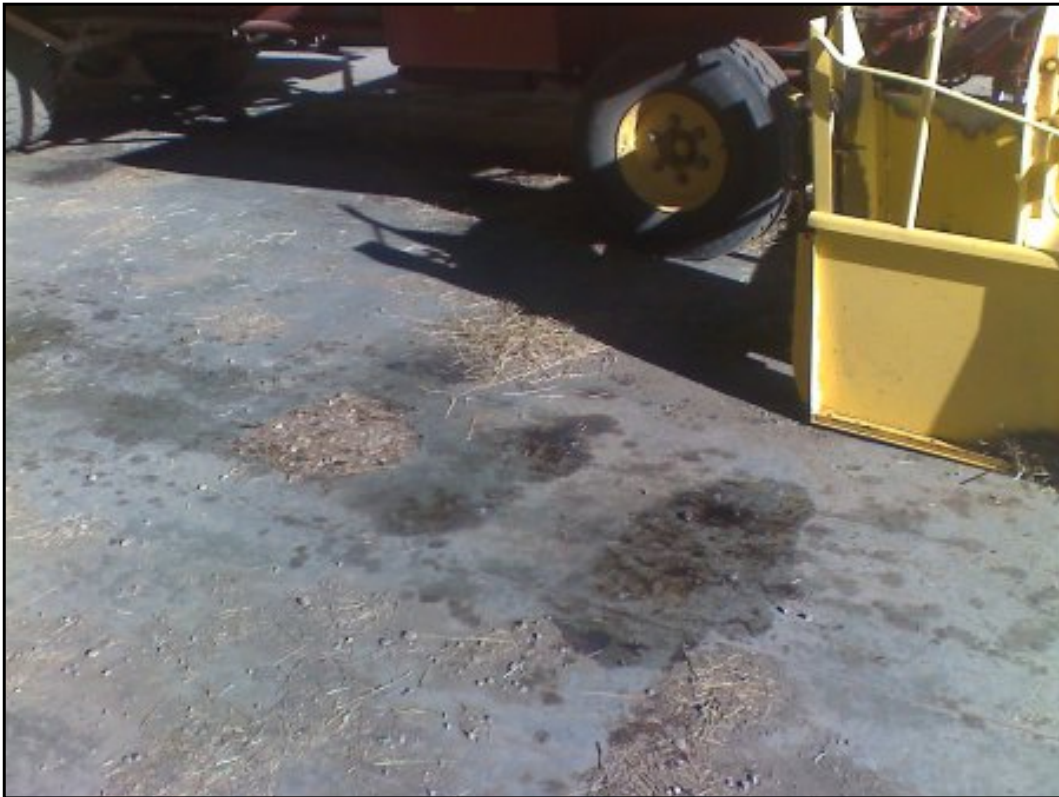
Several oil stains were observed at the time of the site visit on the concrete slab in the Hay Shed. No other stained surficial materials were observed on the Site during the site visit.

Oil stains located on the concrete slab inside the hay shed.

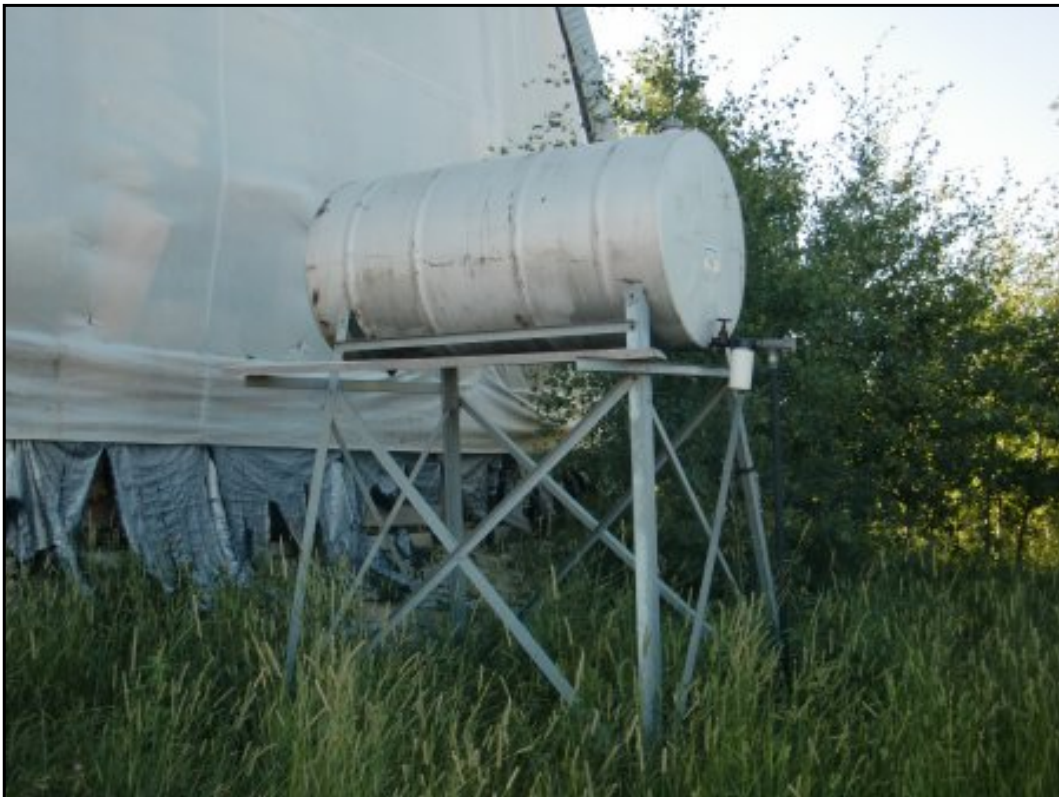
One AST is located on the site, immediately west of the Hay Shed in the southeast portion of the Site. It is used to store diesel fuel which supplies the on site farm tractors and equipment. The tank has an unknown volume and is reported to be over 20 years old. No leaks or spills related to this AST were observed or reported to Stantec. At the time of the site visit, surficial rust was noted on the exterior of the AST. No odours were identified and vegetation under and around the AST did not appear to be stained or stressed at the time of the site visit.

AST containing diesel fuel, located west of the hay shed.

An AST containing diesel fuel has been located to the west of the hay shed, located in the southeast portion of the Site, since approximately 1998. The AST represents an ongoing potential environmental concern. It is recommended that a secondary containment that can hold 110% of the existing AST contents be used. In addition, long grasses that were observed at the time of the site visit should be removed for fire control. It is Stantec's understanding that the AST will be removed from Site upon redevelopment. If spills or staining are identified in the future, an environmental professional should be consulted at that time.

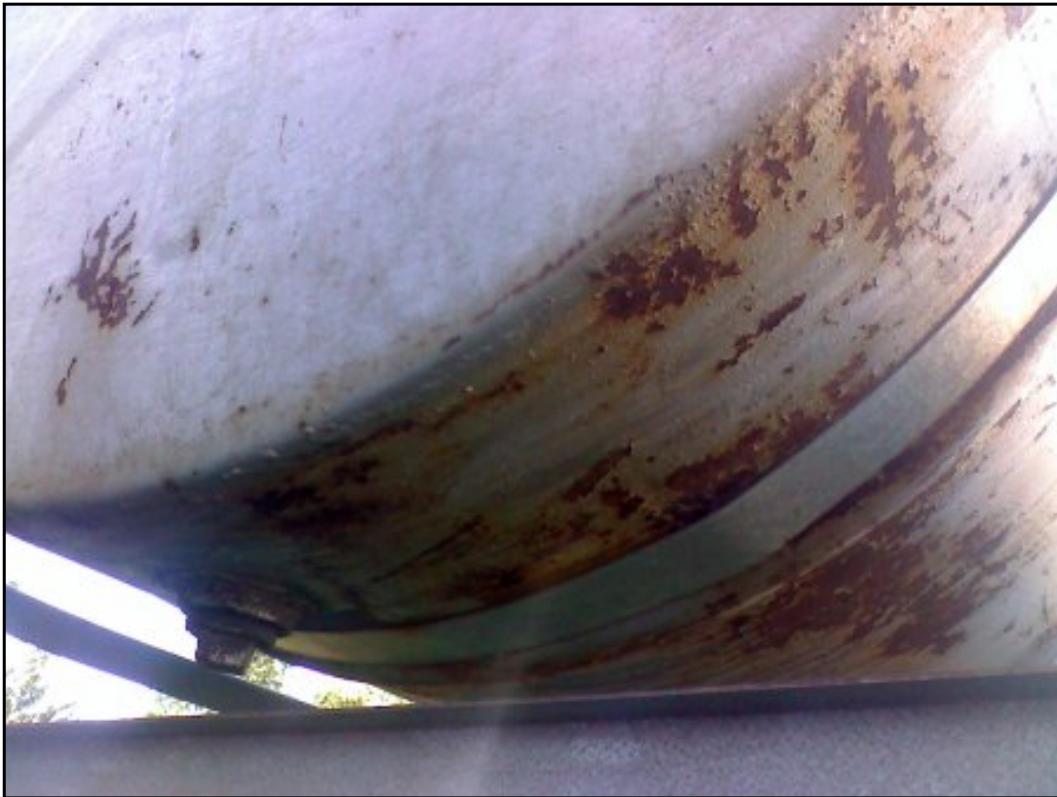
Surficial rust located on the underside of the AST.

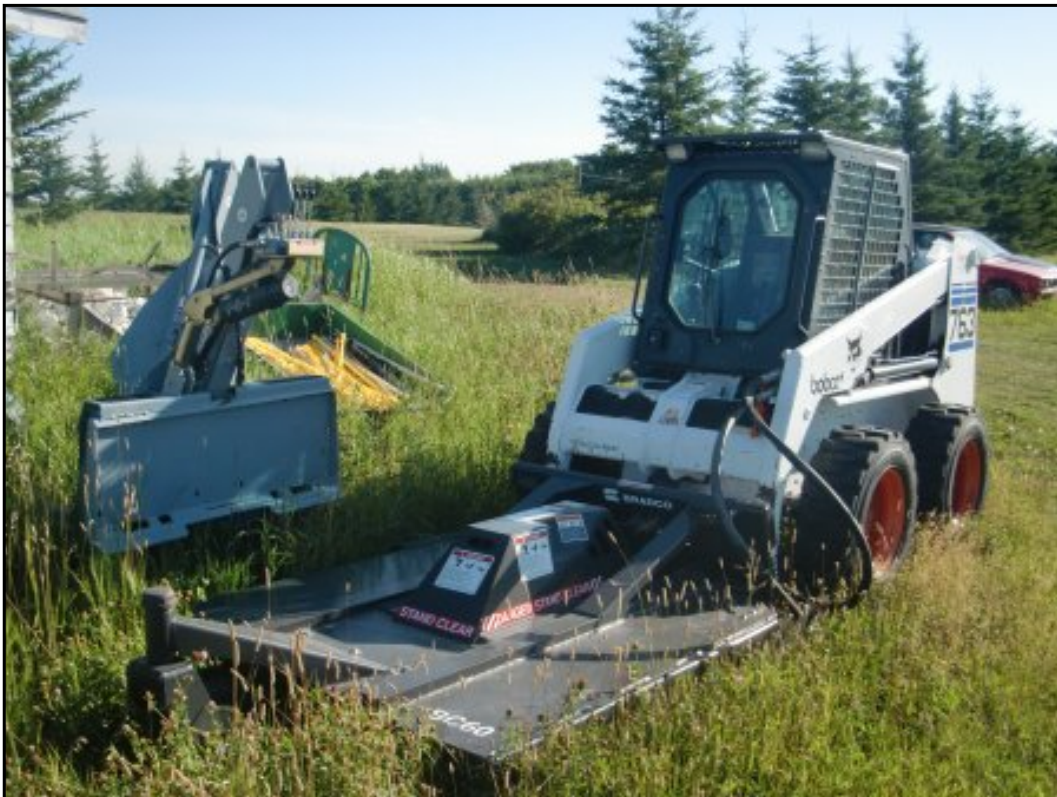
At the time of the site visit, no hydraulic equipment associated with the building systems were observed at the time of the site visit. However, a bob cat is used on Site and contains hydraulic lines. No visible leaks were observed or reported to Stantec.

Bobcat with hydraulic lines.

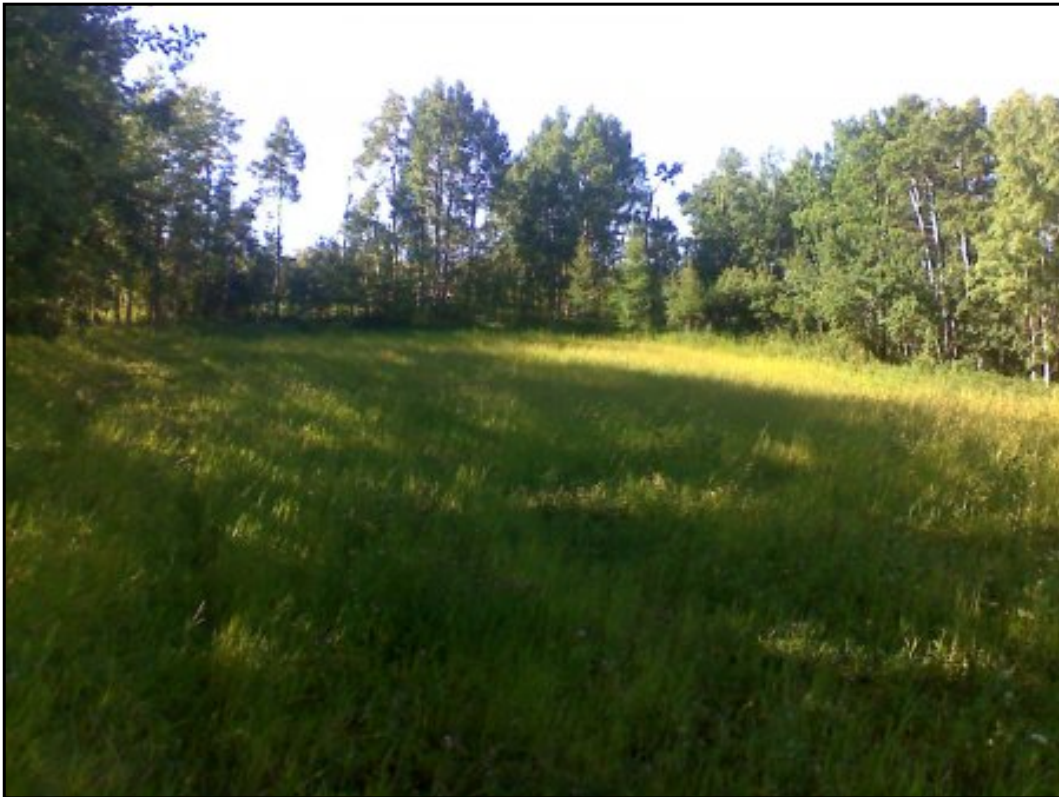
According to Ms. Cartwright, domestic garbage had been burned in a steel drum north of the residential property from 1988 to 1994. In approximately 1991, construction debris including small pieces of wood, insulation, carpet and drywall were used to fill a low area located on the north side of the driveway. It was indicated to Stantec that neither the historical burn pit, or the buried construction debris are in the area of construction for the proposed golf course, and therefore will not be disturbed.

Location of septic tank and historical burn pit, north of the residential property, looking south.

Domestic garbage had been burned in a steel drum from approximately 1988 to 1994 in a location north of the residential property as shown in **Appendix B** (Photo No. 12 and 13). The discarded and burned domestic waste represents a low environmental concern. Discarded material should be removed and disposed of appropriately. According to Ms. Cartwright, the area where the historic burn pile is not included in area of development.

A septic tank is located north of the residential building, located in the east central portion of the Site. The tank was installed in approximately 1988 and has not required maintenance. It is recommended that a Phase II ESA be conducted to evaluate subsurface conditions. According to Ms. Cartwright, the area where the septic tank is located is not included in the area of development.

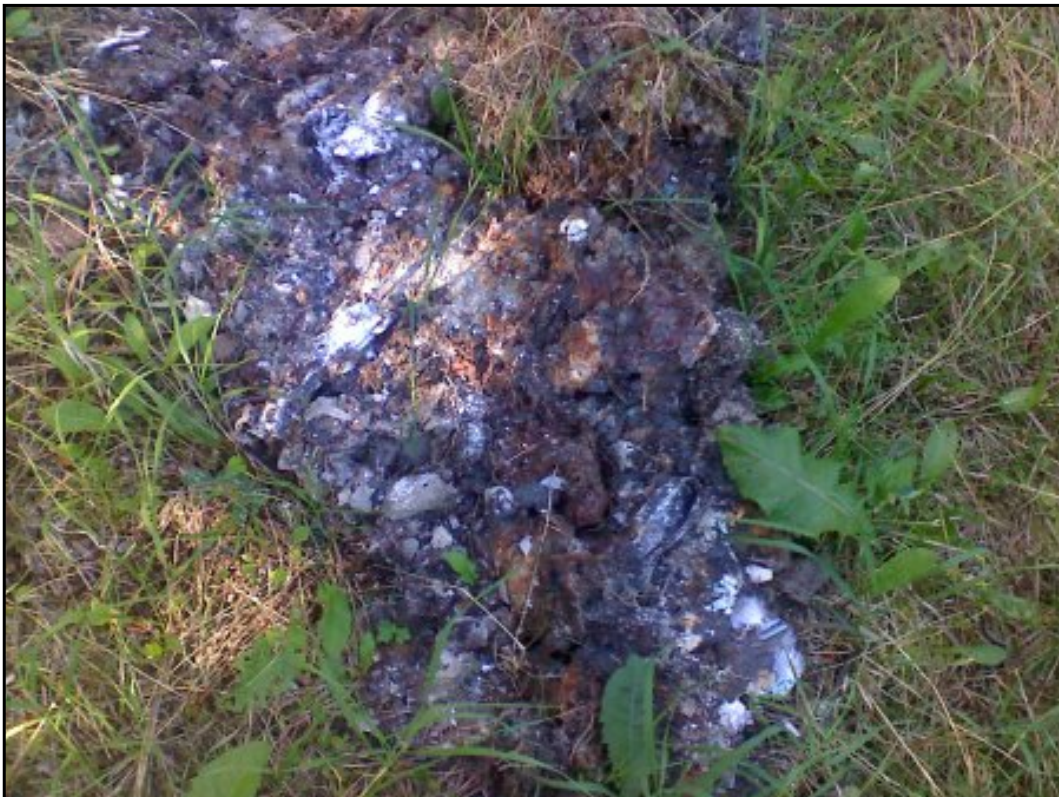
Debris pile from historical burn pit consisting of glass, metal, cinders, and unidentifiable debris.

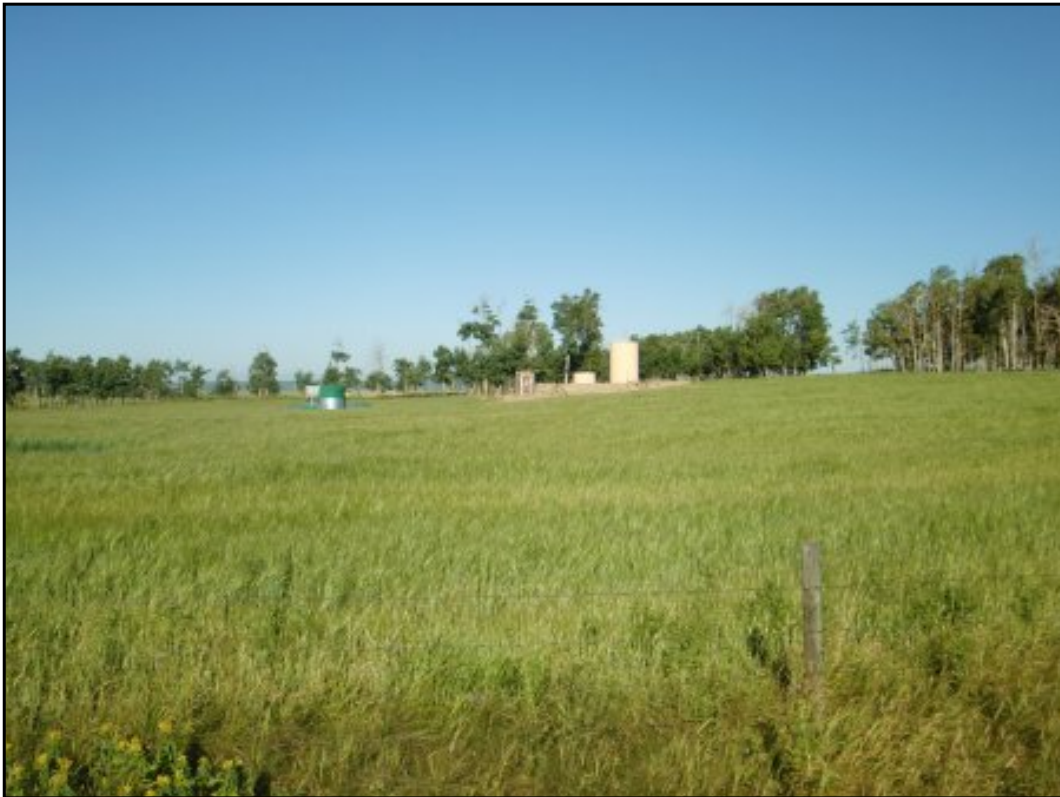
Based on a review of the available historical and regulatory information, the quality of the surface and subsurface (e.g. soil and groundwater) in the vicinity of the crude oil well lease property may have been adversely impacted by the former drilling and fracturing activities. Furthermore, the presence of a bulk fuel AST within 80 m west of the Site is considered to represent an ongoing potential environmental concern. Based on the distance from the Site (80 m west), the presence of AST at the lease property, and the anticipated regional direction of groundwater flow (south to southeasterly towards the Site), the historical and current operations associated with the crude oil well lease property are considered to represent a potential concern to the Site.

An active crude oil well approximately 80 m west of the site. Note the barbed wire fence in the foreground indicating property line.

The Phase I ESA has revealed evidence of potential environmental concerns associated with the Site as summarized above. Based on the findings of this Phase I ESA, it is recommended that an intrusive investigation be conducted for due diligence purposes on Site in the area of the crude oil well lease to determine if the surrounding soil and/or groundwater has been impacted by the operation. Additionally, an intrusive investigation should be conducted in the area of the septic tank. Historical burned debris located north of the residential property should be removed and disposed of at an approved facility. Finally, vegetation in the area of the AST west of the hay shed should be removed to mitigate the fire hazard. During development, excavated material and any exposed subsurface soils should be monitored for visual or olfactory evidence of potential environmental impacts. If potential impacts are identified, further assessment by an environmental consultant is recommended.
